FIELD INVESTIGATIONS OF UNCONTROLLED HAZARDOUS WASTE SITES

Hydrogeologic Report on the
Federal Marine Terminals Property
Riverview, Michigan
TDD# F5-8007-5C

March, 1982

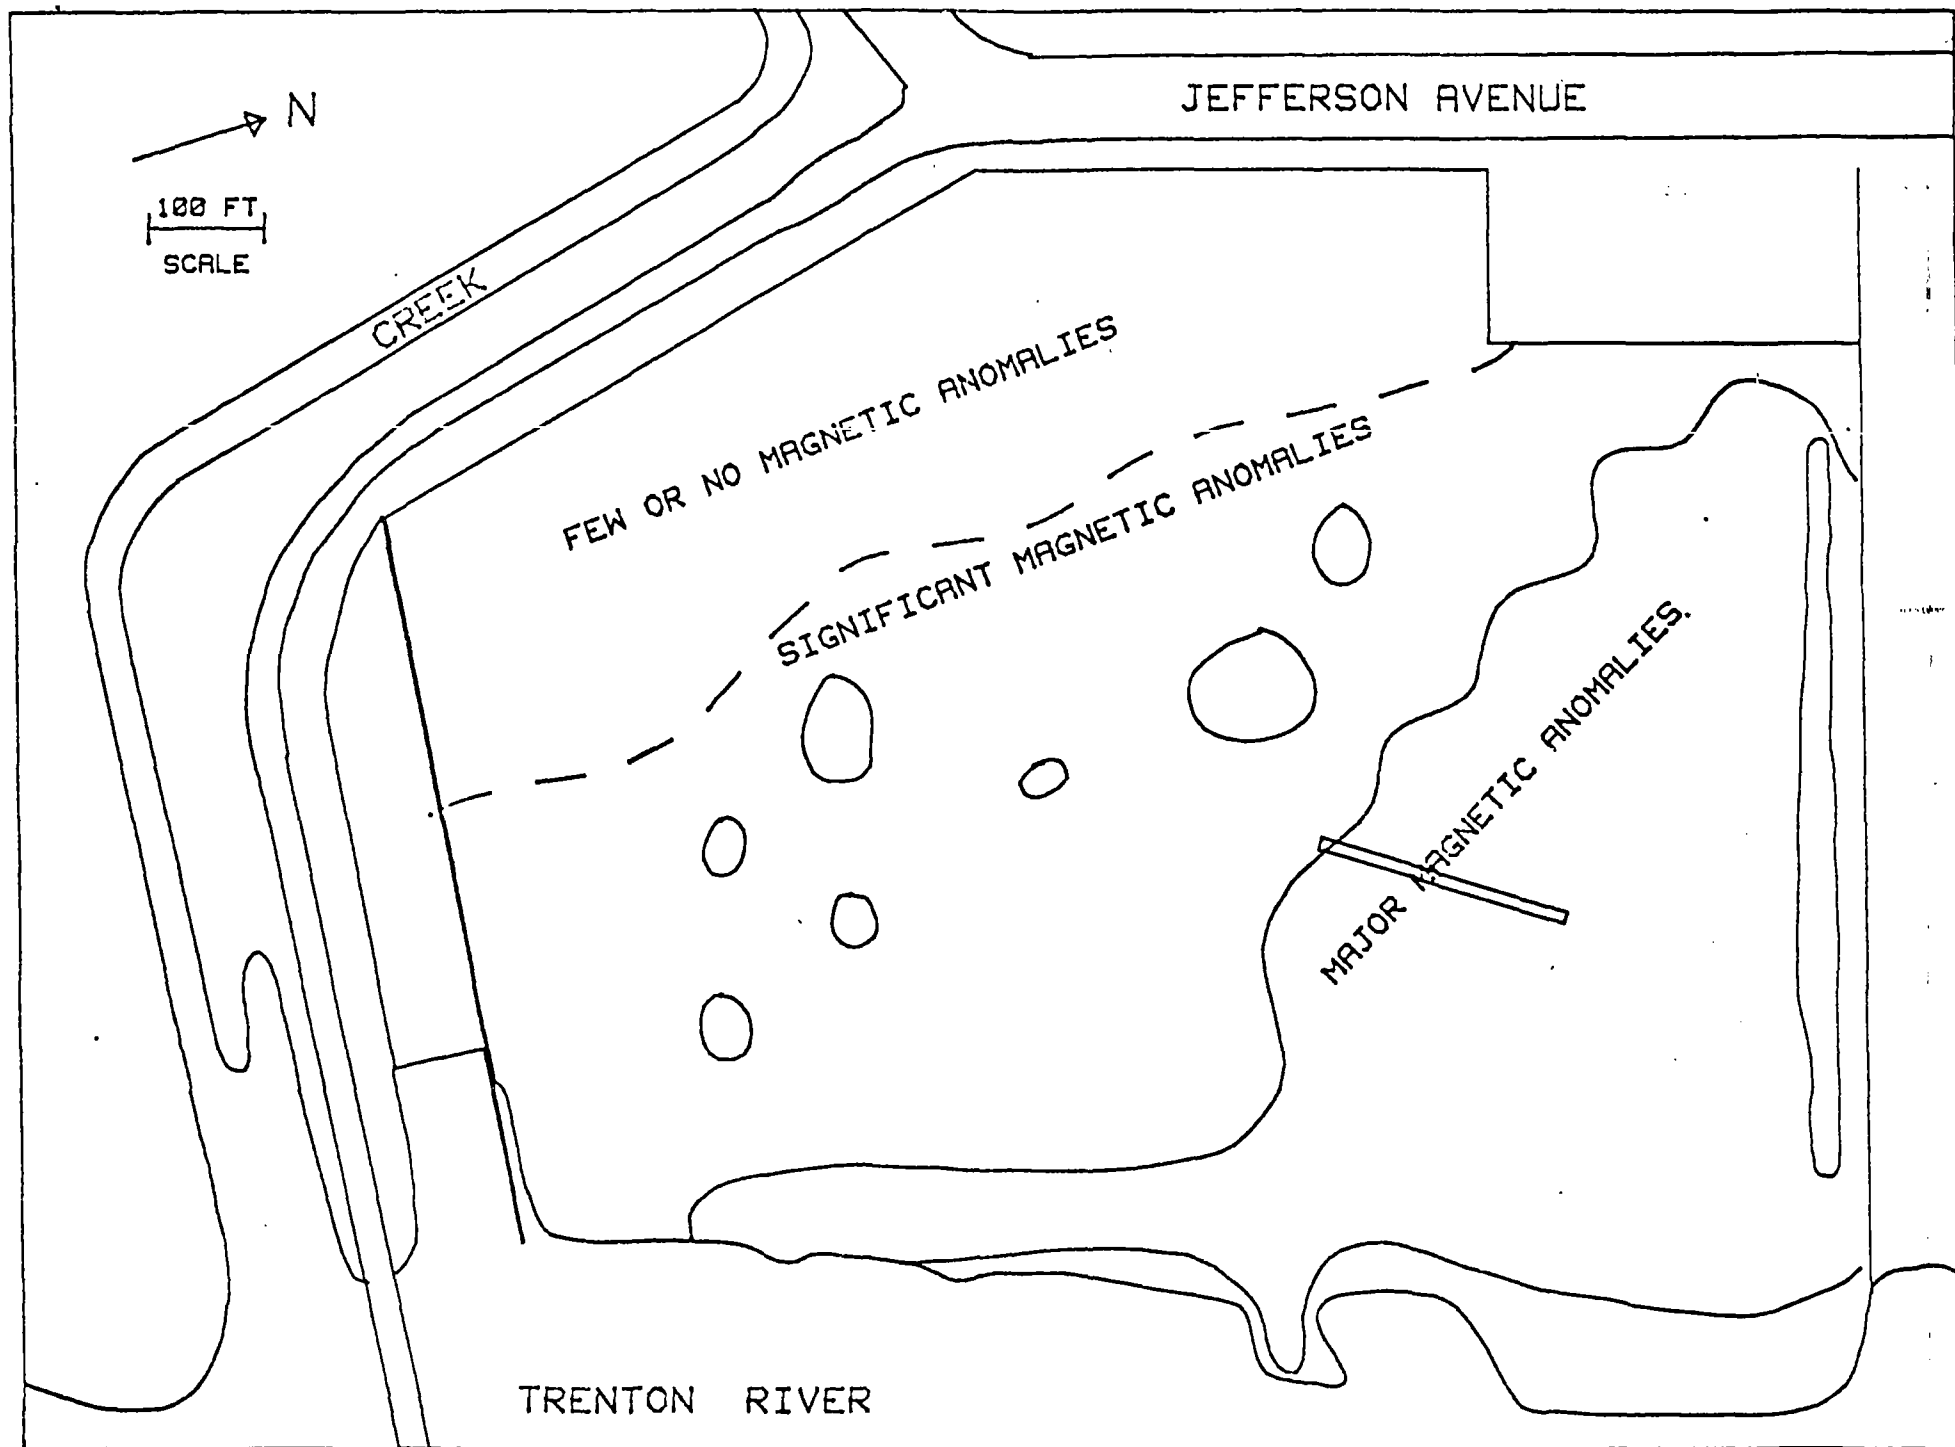
Figure 1 : F.M.T. Site; Magnetic Anomaly Distribution

Figure 1 shows the spatial distribution of magnetic anomalies across the site. As is depicted in this figure, the highest accumulation of buried ferrous materials exists in the northeast quadrant of the property. Fewer anomalies were detected across the central portion of the site. The southwest and western portions of the area showed few or no anomalies.

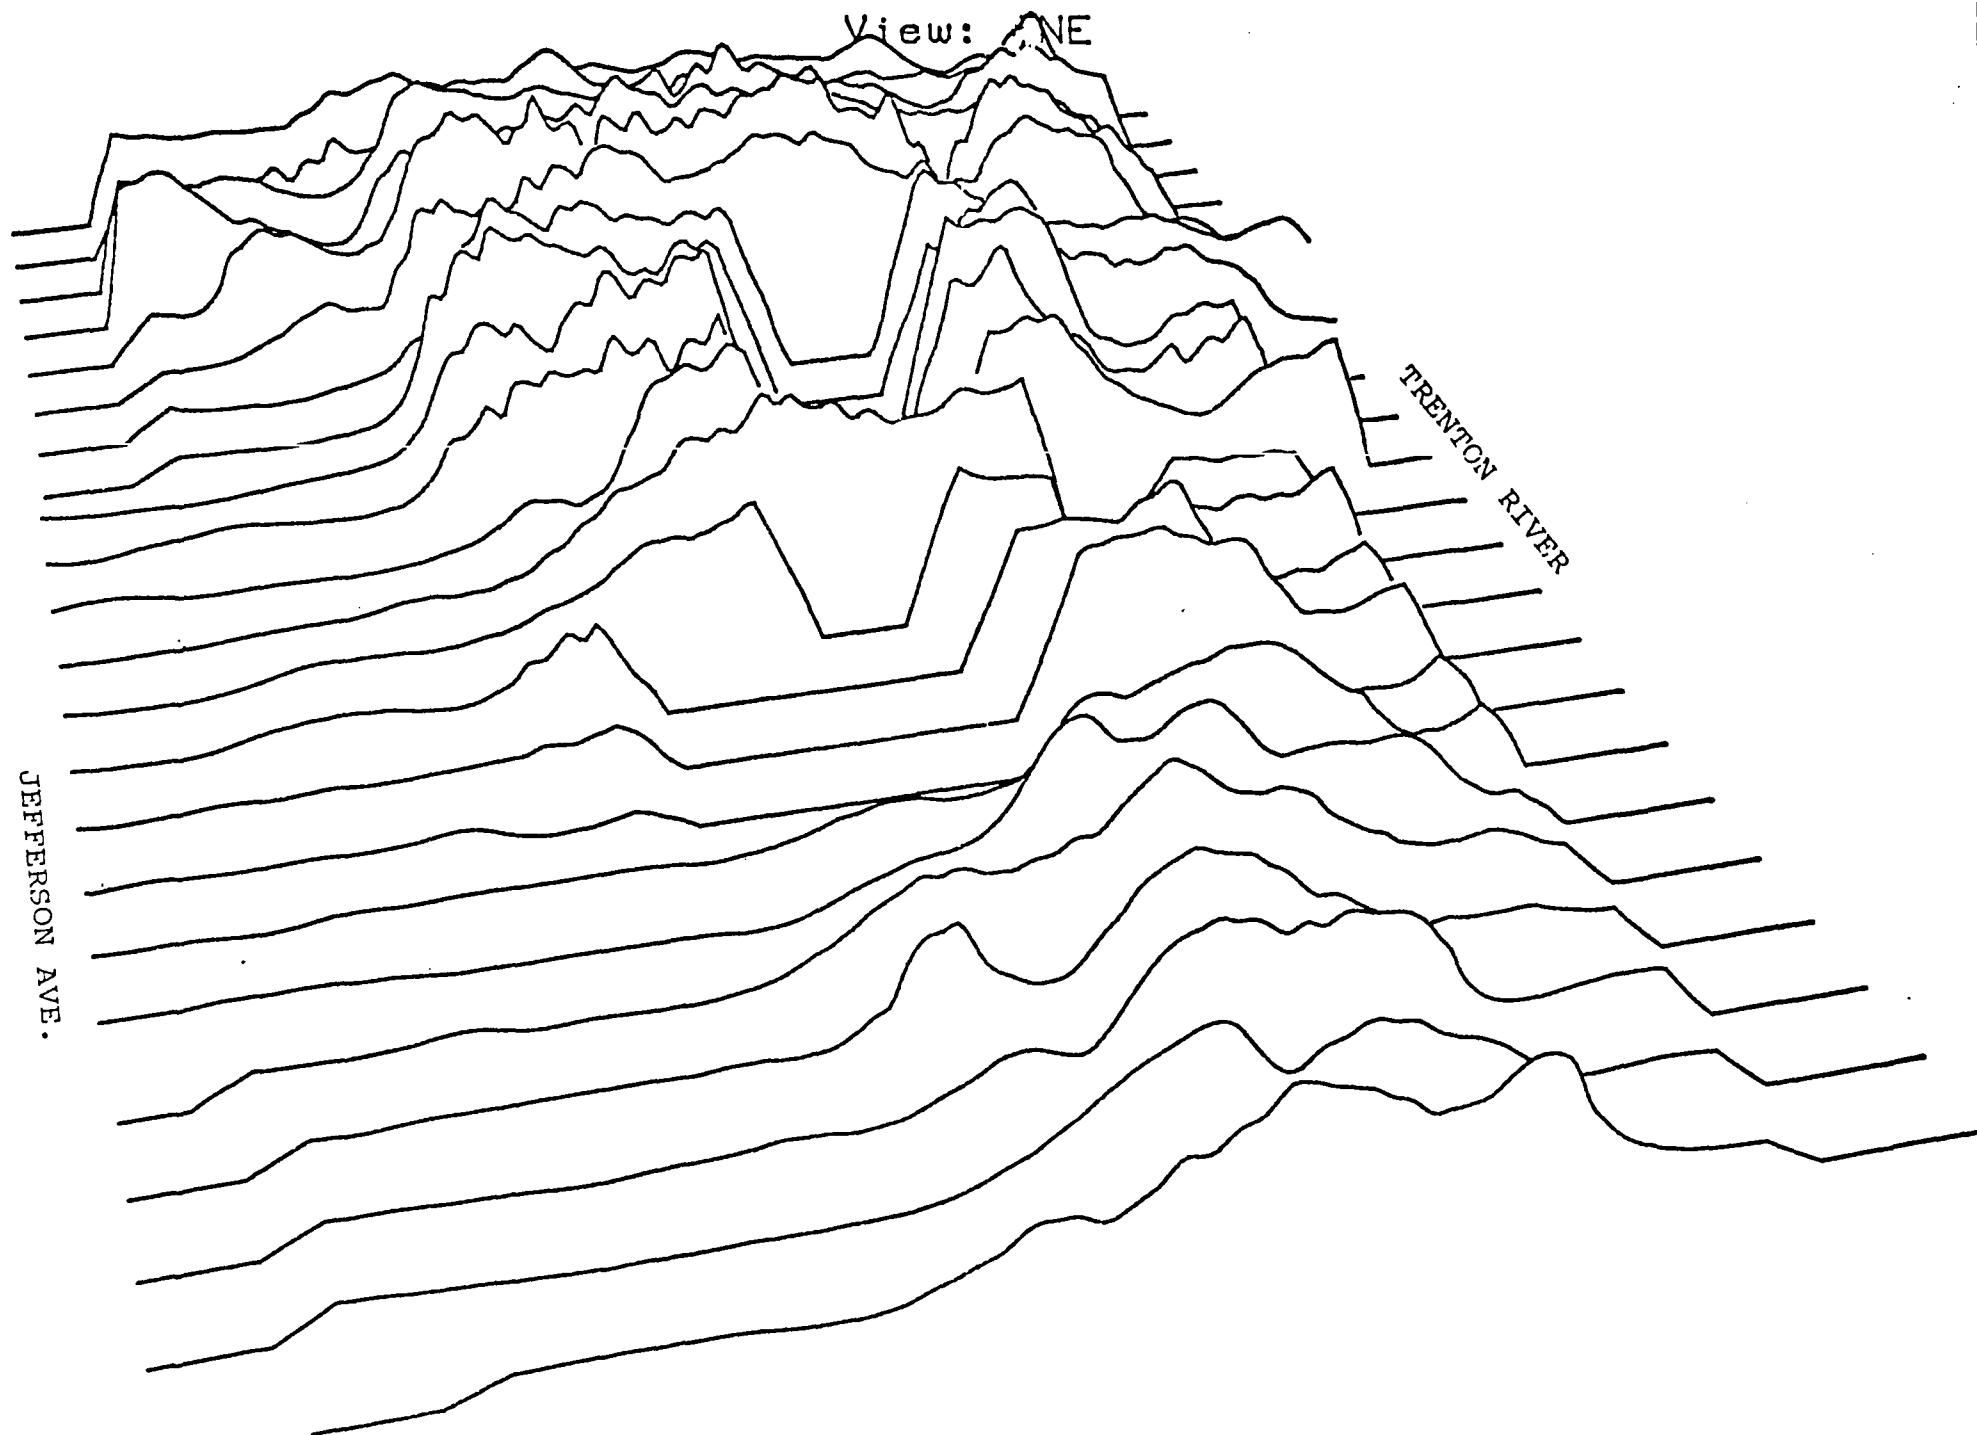
Figure 2.A: F.M.T. Site; 3-Dimensional Conductivity Plot, northeast view.
Figure is approximately to scale, 1000 by 1200 feet.
GROUND CONDUCTIVITY

Figures 2A, 2B, and 2C are computer generated, 3-dimensional views of the site showing the relative conductivities of the material present. Figures 3A and 3B are contour plots of the same data. As seen in these figures, the northeast and eastern portions of the site show significant increases in conductivity. According to Technos, "conductivities about 60 mm/m appear to be indicative of the clays present in the area". These conductivities found in background clays are nearly one order of magnitude less than the conductivities measured on the northeast portion of the site. Figure 3B magnifies areas along the Trenton Channel where areas of high conductivity meet the river.

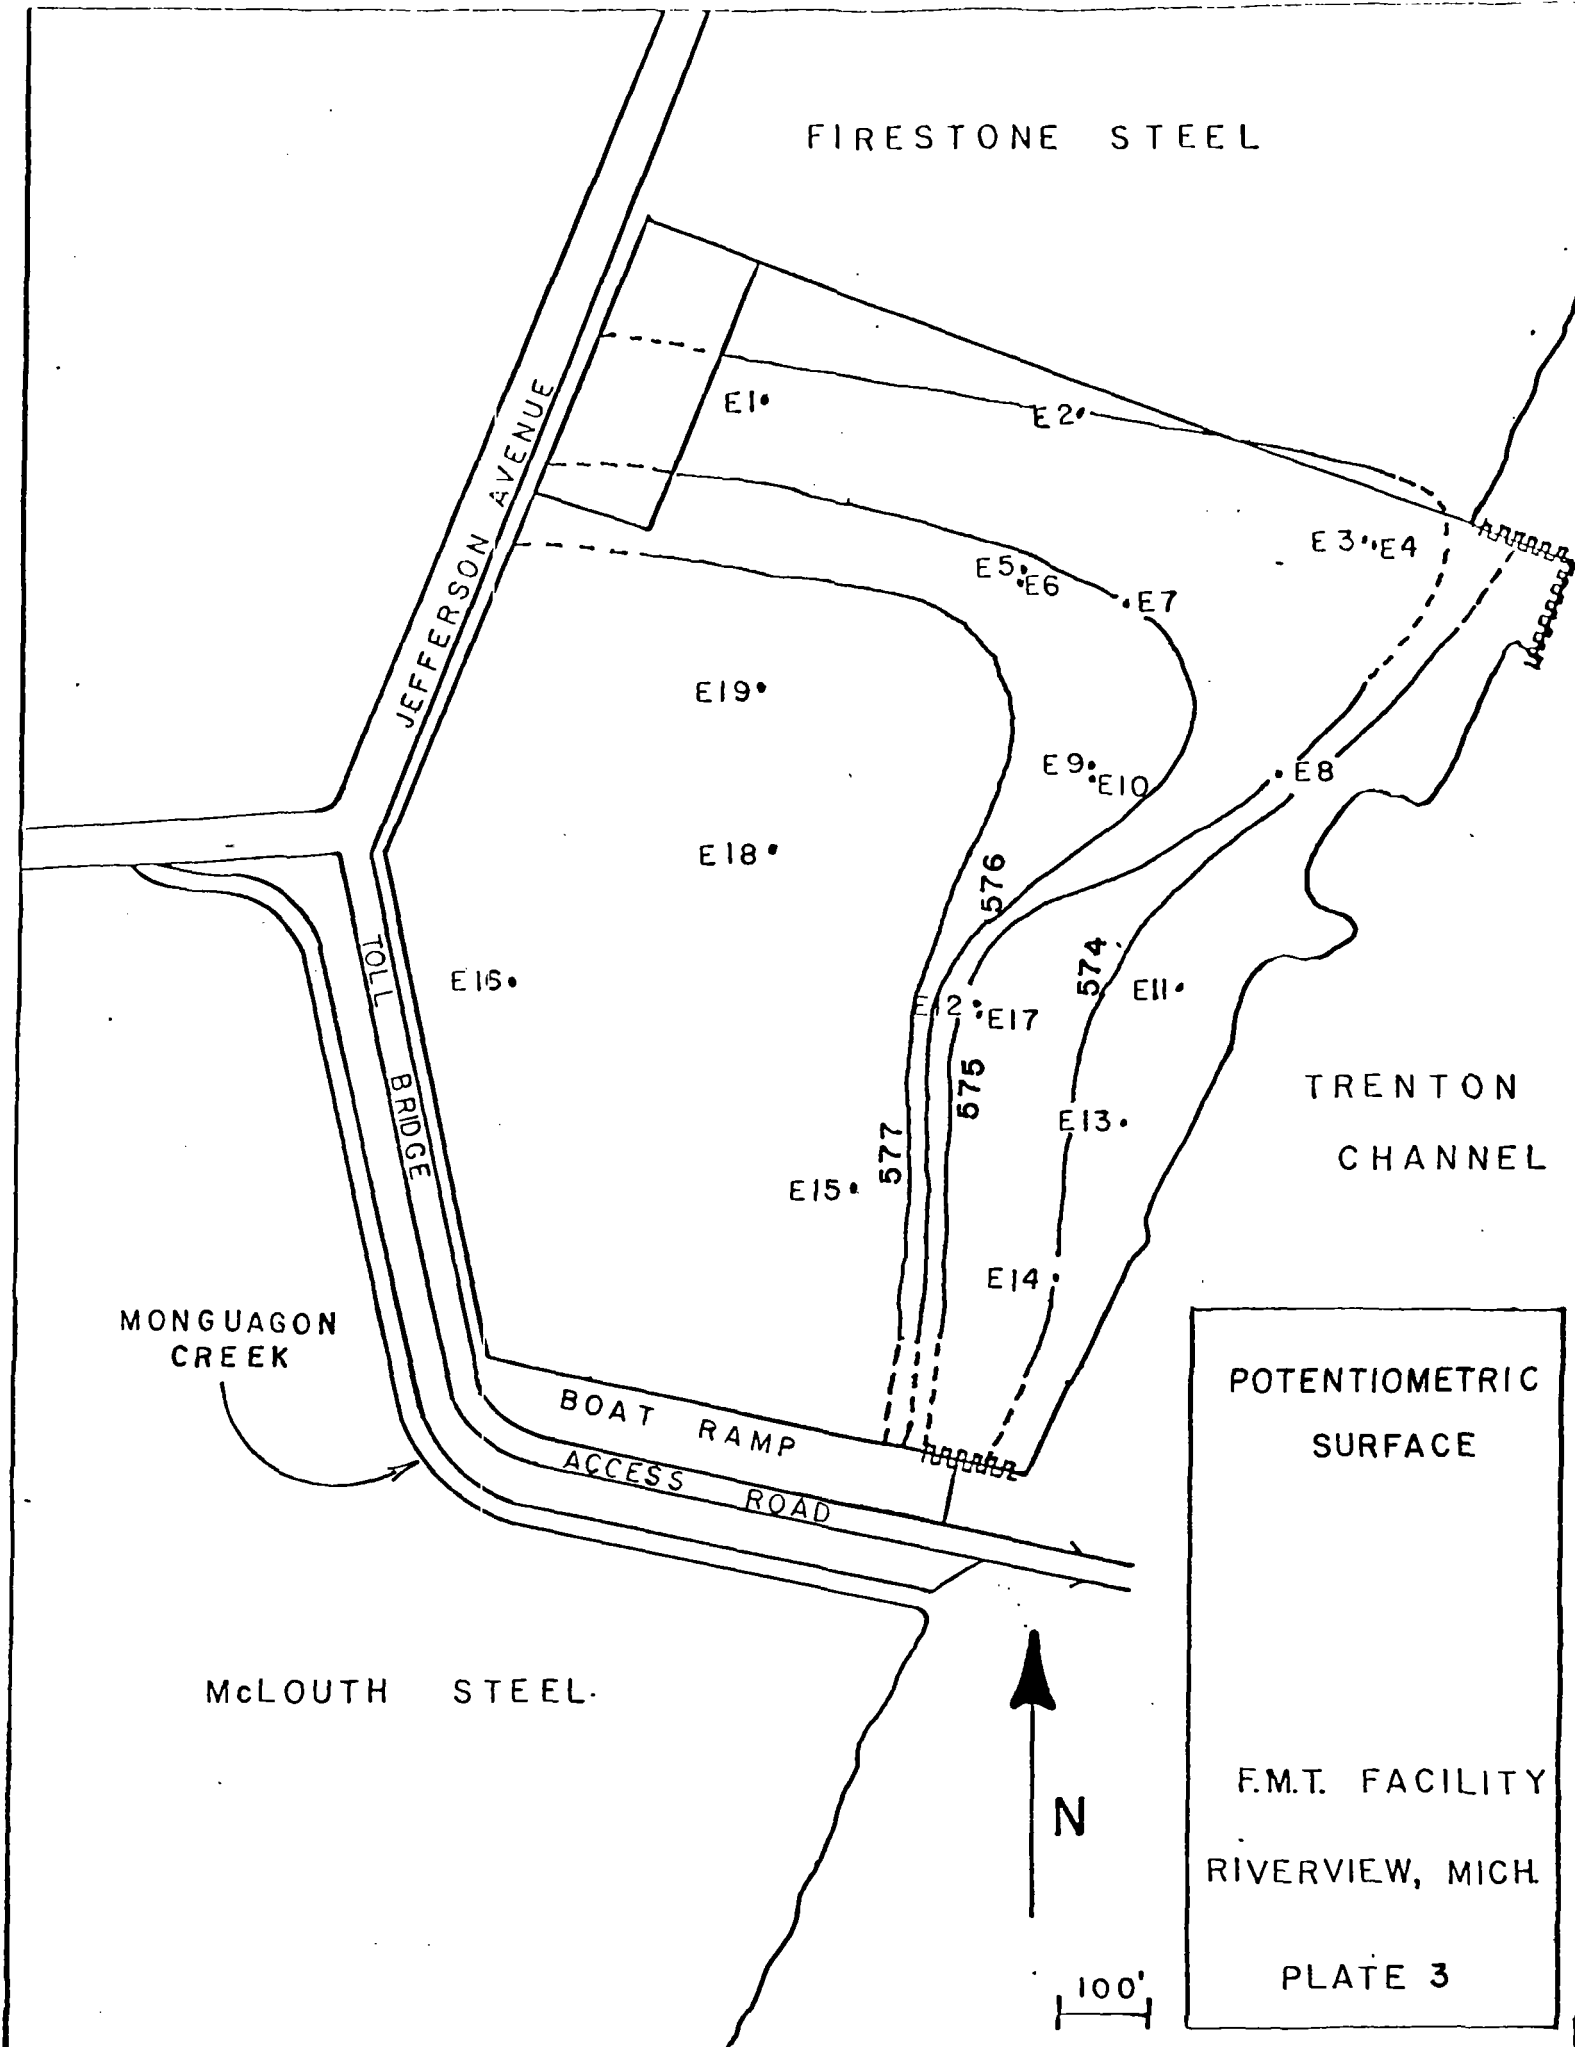
PLATE 3

Plate 3 is a contour plot of the piezometric surface as defined by water level measurements taken on 2/24/81 and 2/27/81. The piezometric surface depicted, verifies the split groundwater flow system as suggested by Dames and Moore. On the western portions of the site, groundwater flow is toward the north. The eastern portion of the site is characterized by groundwater flow toward the river. The correlation between the piezometric surface and the clay-fill interface suggests that groundwater flows across the site on top of the clay. As outlined in Appendix C, the volume of water flowing from the site into the Trenton Channel is approximately 56,000 gallons/year at an estimated velocity of 4 feet/year. It should be emphasized that these figures represent estimates based on the assumptions outlined in Appendix C.

The relative elevations of the piezometric surface and river level suggest that at the time this data was collected, water was moving from the channel into the near stream alluvial deposits and fill material. Communication between the two will naturally result in occasional recharge of the groundwater in this manner.
